Durability improvements of Exhaust pipe joints during operating Condition

Keywords: Weld Fatigue analysis, Flange joint, Exhaust Pipe

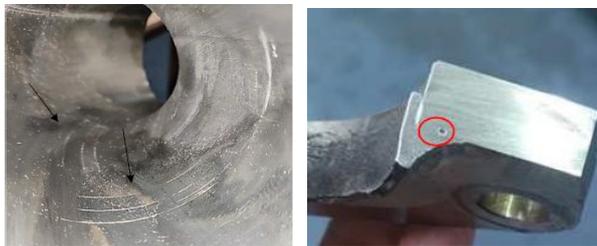
Fig.3 Gas cavity inside weld bead

Welding defect Blow hole was observed on weld near flange end as shown in Fig. 3

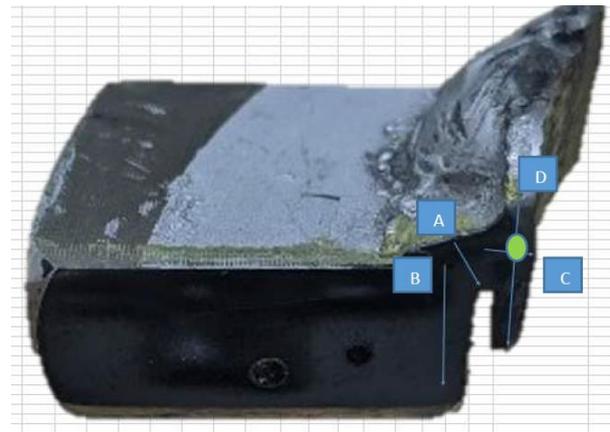
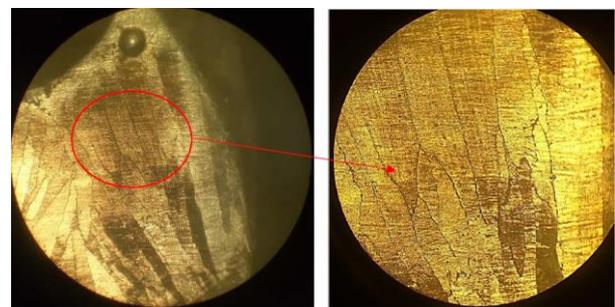
Fig.4 a) Cross-section of weld zone b) Microscopic image of weld zone

Above details of microstructural images in Fig.4 helped to identify the points where spikes can be seen. For example in Fig.4 , sudden spikes in hardness can be observed in graph C and D at the intersection point of two lines (highlighted in green). Crack also observed in the same area parallel to weld zone (Fig.4- a, b)

4. Optimum torch angle which can produce results described in above points should be recorded in Welding Procedure Specification (WPS).
5. Micro hardness should be measured and difference in Parent metal and HAZ hardness should not be more than 15% of base metal.

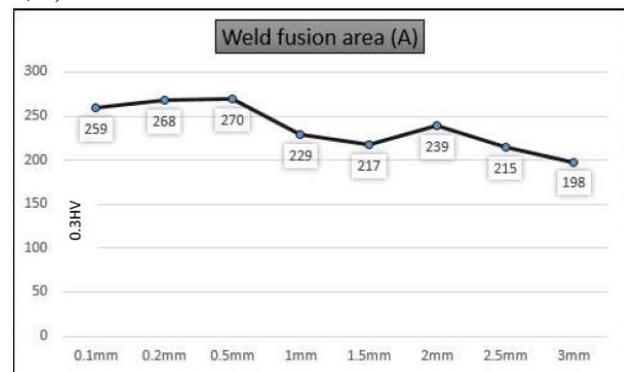
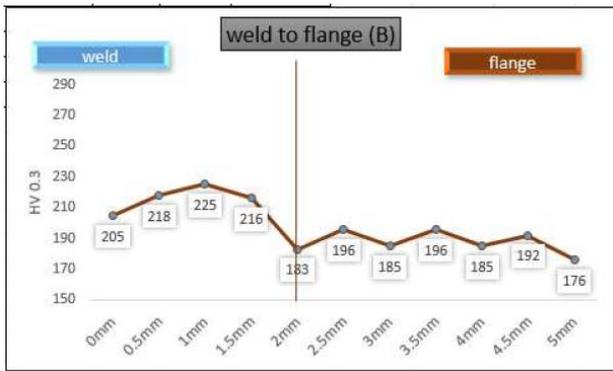
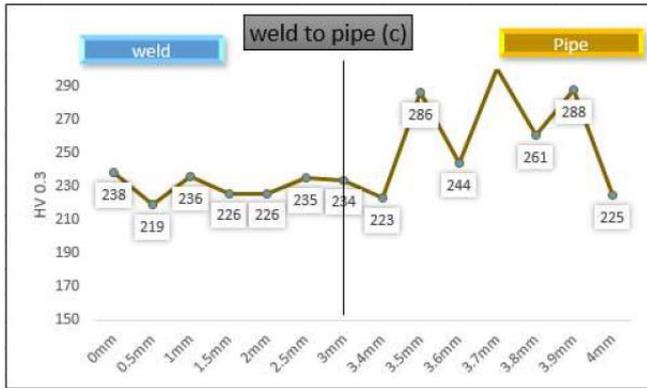
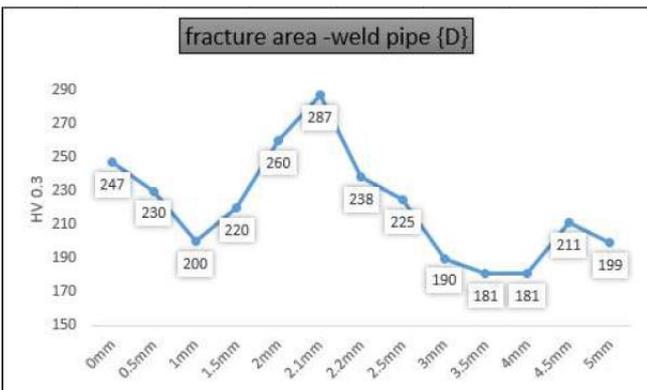
Fig.5 Hardness Value at different identified locations

Fig.5 gives Hardness values at different distances along the directions A, B, C & D

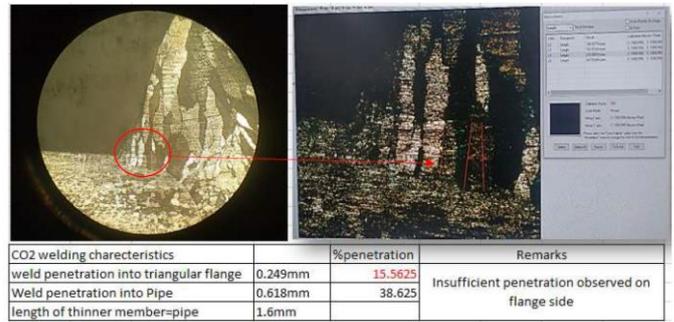
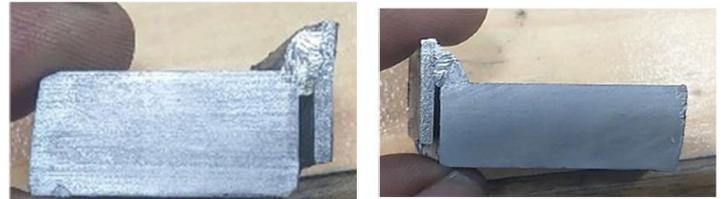
Fig.6 Images of weld penetration

Arc welding penetration was observed as per specification, leg length and weld throat thickness mentioned as per Standard. A weld joint cross section sample was prepared and observed under microscope and weld penetration was measured with the inbuilt software of microscope as shown in Fig.6. The weld penetration in flange in some samples were found less than that specified in standard.

1. Weld penetration on tube wall should be limited to 20-50%.
2. Weld parameters should be selected to ensure enough weld penetration on flange (>20%).
3. Weld heat should be focused on Flange. A guiding ratio of 70% (flange) and 30% (tube) for weld heat distribution should be applied. The concentrated heat on flange should be sufficient to generate enough wetting/puddle on tube to produce 20-50% weld penetration on tubes. A good number of cut samples should be analyzed to confirm the penetration as recommended in earlier points

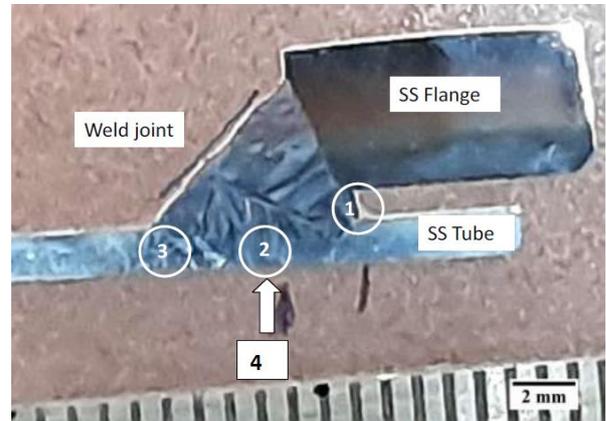
Fig.7 SS Weld joint - SEM imaging locations are encircled and numbered

- 1) There is a gap of ~1mm between SS flange and SS tube in the lap part of the weld joint (as shown in Fig.7).
- 2) There is small crack / undercut on the both sides of weld pool between SS flange and SS tube towards the SS flange side of the weld joint (as shown in Fig. 11 and Fig. 12).

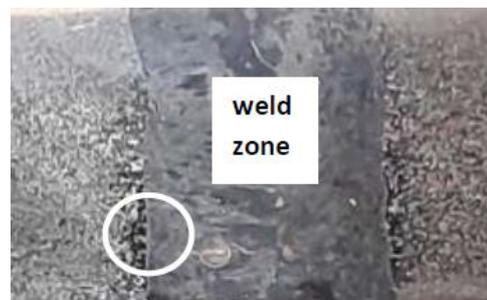
Fig.8 Inner diameter surface of SS Tube at location 4 of Fig.7

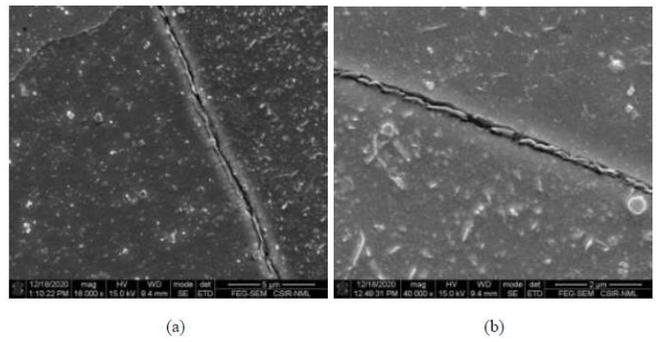
Fig.12 High Magnification image of circled region in Fig.12

Carbide precipitation at grain boundaries of columnar grain can be observed from Fig.12

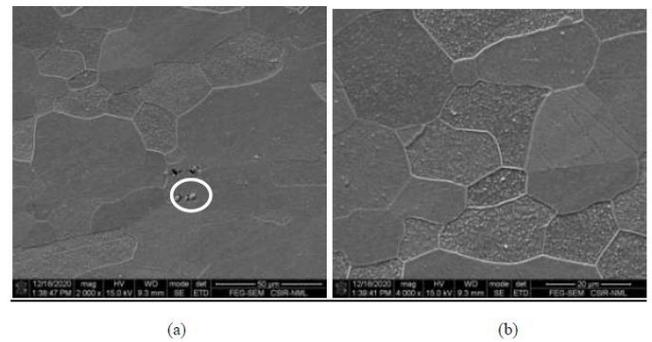
Fig.13 SEM images on location 3, show equiaxed grain.

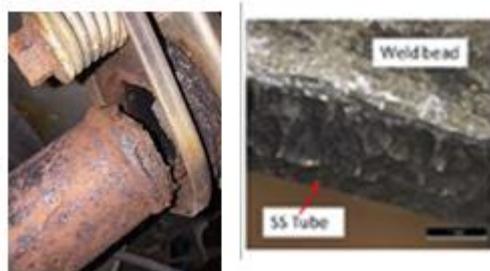
Fig.17 Stereomicroscopy of failed weld joint of exhaust pipe showing the fracture surface location on the SS tube

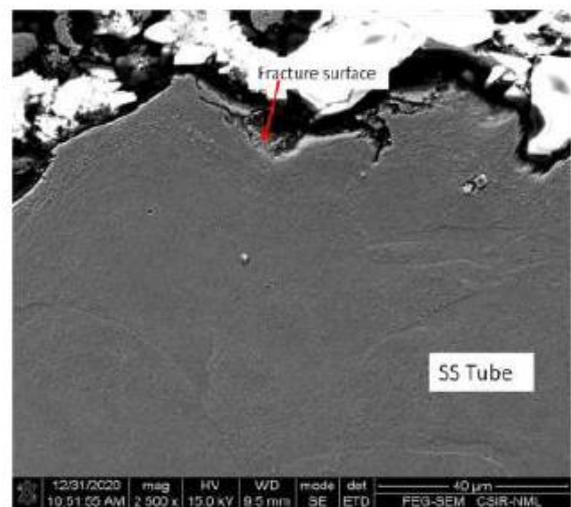
Fig.19 Cross-section microstructure at the fracture location (SEM)

- 1) The cross-section microstructural examination at the failure location clearly revealed that the fracture has occurred at the SS tube with the polygonal grain microstructure. No abnormalities like cracks from the weld zone or inter-granular cracking connected to the fracture surface were observed (Fig.19 and Fig.20).
- 2) The fracto-graphy studies clearly showed the striation features/marks. Presence of striation marks on the fracture surface indicates failure due to fatigue loading. Further, the fracture has initiated from multiple sites on the circumference of the pipe at the location where the weld deposit ends and it propagated towards the inner surface of the tube leading to a failure (Fig.20).
- 3) The studies clearly indicated that the fracture of the exhaust gas pipe has occurred due to Fatigue / cyclic type of loading at the place where the weld deposit ends.

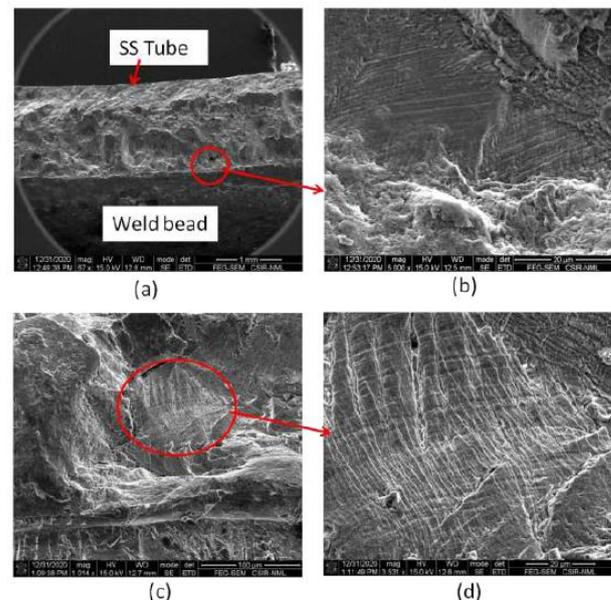
Fig.20 SEM Fractographs (a) Low magnification (b) High magnification region of (a) showing fatigue beach marks/striations (c) High magnification at another location (d) Fatigue Striations at high mag. taken from encircled region of fig.(c)

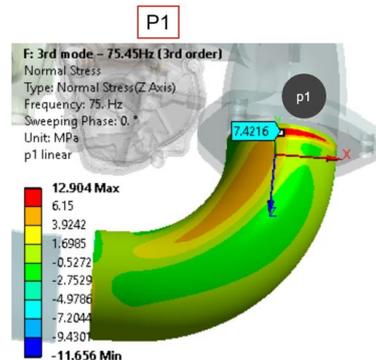
Fig. 22 Resonance vibration analysis of weld joint
