The valorization of classified historical monuments in Algeria, a controversial issue: The case of the Agha Palace in Ferdjioua,.

Habiba Souki¹, Nadia Chabi²

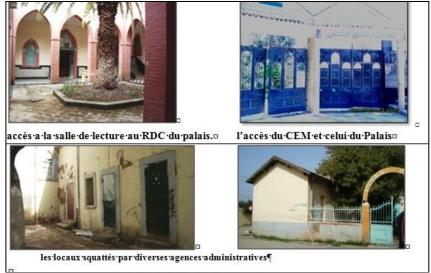
Figure 02: the uses of the palace

The Palace of the Agha: transformations of the monument and changes of use. The Monument underwent several modifications there are parts covered with terraces others by frames. First, the construction of the enclosure itself, which was the residence of the governor, was the palace of Sheikh Ahmed Bouakaz in 1834. In 1929. The monument has undergone a first restoration and an extension by adding the second floor. The accesses were fortified with iron gates [⁴].

Two wings were added to the palace, today this part of the palace is used by the Scouts. A line of palm trees was also added to the ensemble with a line of stone paving that overlooks a fountain built in front of the door of the former governor's house.

The garden with its important surface was the object of covetousness of several administrations. It is only in 1990 that the commune allowed the direction of education to implant in the northern part a C.E.M decreasing its total surface. As for the last change, it was materialized by the construction of a MATECO (sports ground) for the C.E.M. in the center of the garden next to the fountain and near the palace. Since its construction until today, the palace has had several uses, which each time give it a different status.
