Durability improvements of Exhaust pipe joints during operating Condition

Keywords: Weld Fatigue analysis, Flange joint, Exhaust Pipe

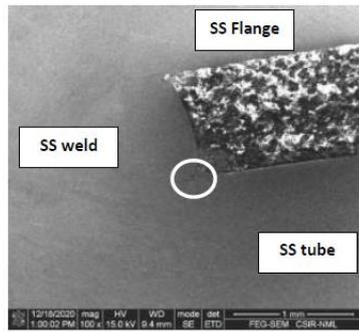
Fig.9 Low Magnification image of location 1 in Fig.7

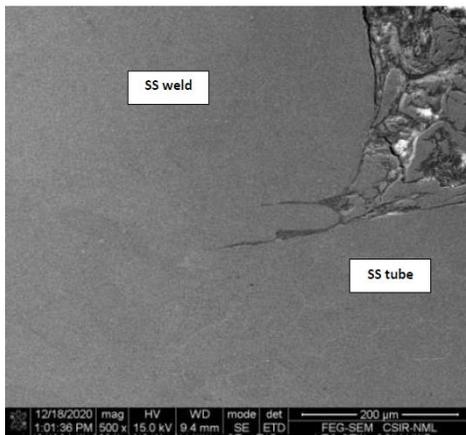
Fig.10 High Magnification image of circled region in Fig 8

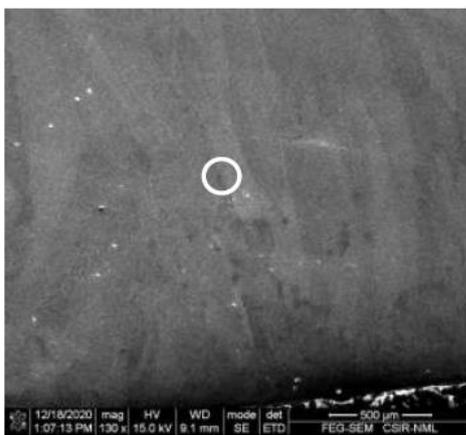
Fig.11 Low Magnification image of location 2 in Fig.7 (columnar grain)

- 1) There is a gap of ~1mm between SS flange and SS tube in the lap part of the weld joint (as shown in Fig.7).
- 2) There is small crack / undercut on the both sides of weld pool between SS flange and SS tube towards the SS flange side of the weld joint (as shown in Fig. 11 and Fig. 12).

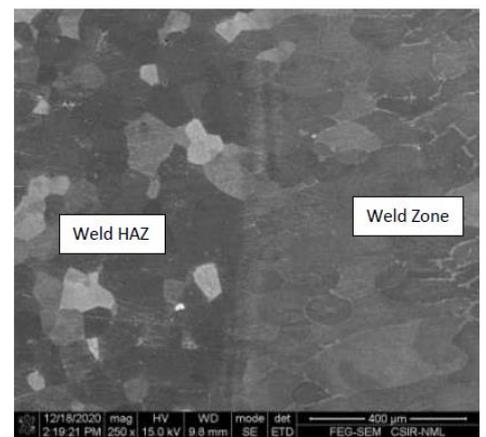
Fig.14 SEM image of marked location in Fig.8

- 3) The weld fusion affected zone up to inner diameter surface of SS tube showed columnar grains with heavy carbides precipitated at grain boundaries (as shown in Fig. 13 and Fig. 14.

- 4) Figs.12, 13 and 14 shows the polygonal equi-axed grains on the SS tube HAZ side with expected precipitates of rich in Nb and Ti. No abnormal carbide precipitation at GB was observed as in the case of columnar grain boundaries.

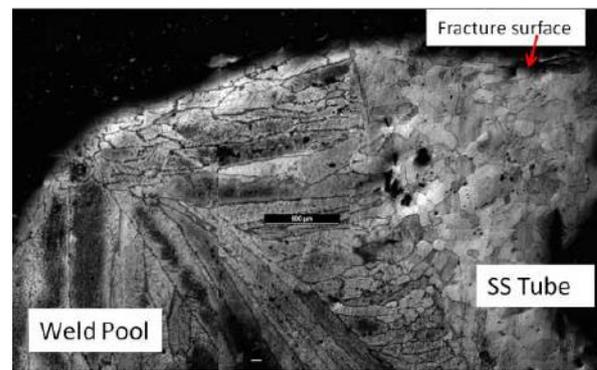
Fig.18 Cross-section montage microstructure at the fracture location

- 1) The cross-section microstructural examination at the failure location clearly revealed that the fracture has occurred at the SS tube with the polygonal grain microstructure. No abnormalities like cracks from the weld zone or inter-granular cracking connected to the fracture surface were observed (Fig.19 and Fig.20).
- 2) The fracto-graphy studies clearly showed the striation features/marks. Presence of striation marks on the fracture surface indicates failure due to fatigue loading. Further, the fracture has initiated from multiple sites on the circumference of the pipe at the location where the weld deposit ends and it propagated towards the inner surface of the tube leading to a failure (Fig.20).
- 3) The studies clearly indicated that the fracture of the exhaust gas pipe has occurred due to Fatigue / cyclic type of loading at the place where the weld deposit ends.

1. Weld penetration on tube wall should be limited to 20-50%.
2. Weld parameters should be selected to ensure enough weld penetration on flange (>20%).
3. Weld heat should be focused on Flange. A guiding ratio of 70% (flange) and 30% (tube) for weld heat distribution should be applied. The concentrated heat on flange should be sufficient to generate enough wetting/puddle on tube to produce 20-50% weld penetration on tubes. A good number of cut samples should be analyzed to confirm the penetration as recommended in earlier points

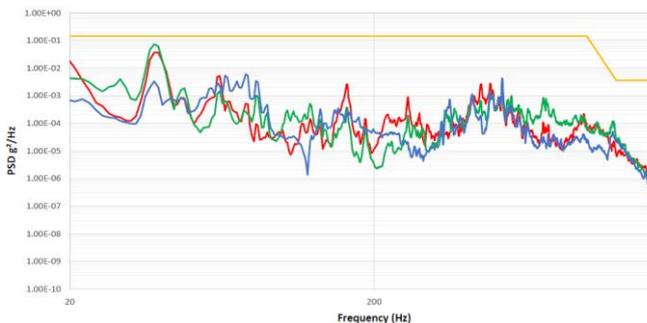
In order to simulate fatigue behavior of weld joints in actual loading conditions, Road Load data was captured using accelerometers. The PSD profile (Fig. 22) thus captured used in fatigue analysis of the weld joints. The acceptance criteria of the design was set at $D < 1$ (D- Cumulative damage Factor). Refer Fig 22

Fig. 21 Example of a PSD profile
